March 14, 2023

Subject: Engineering Consulting Services Report
HURRICANE IAN WINDOW DAMAGE REVIEW
Bridgewater at Bonita Beach
4975 Bonita Beach Road South
Bonita Springs, FL 34134
SOCOTEC Project Number VS230195

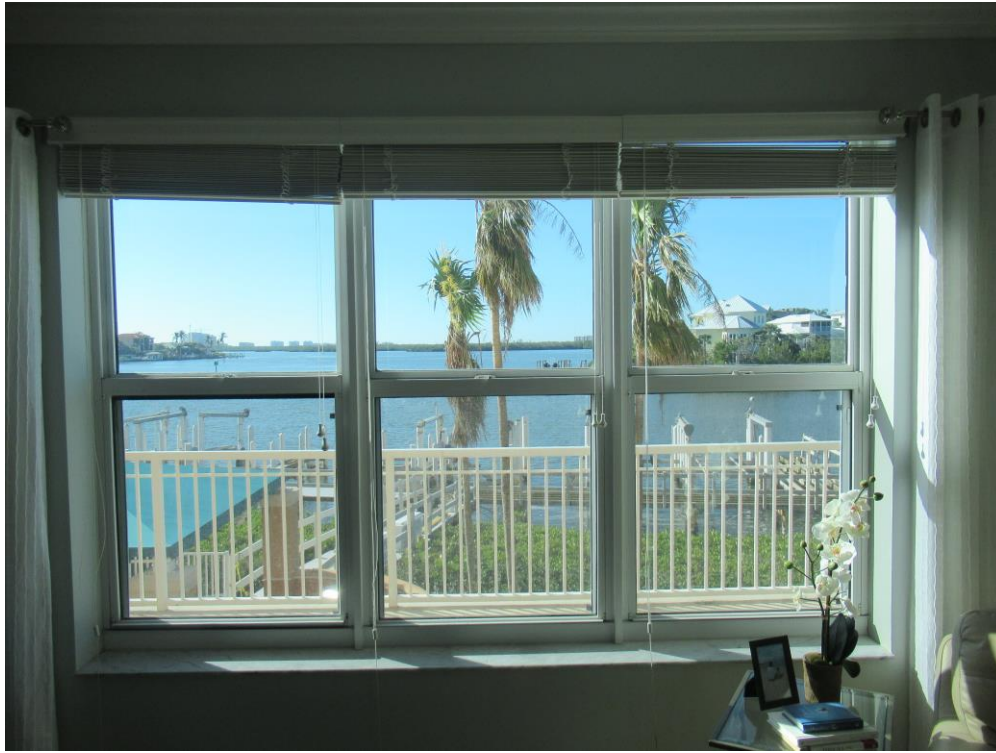
Overview of a window in unit 107.

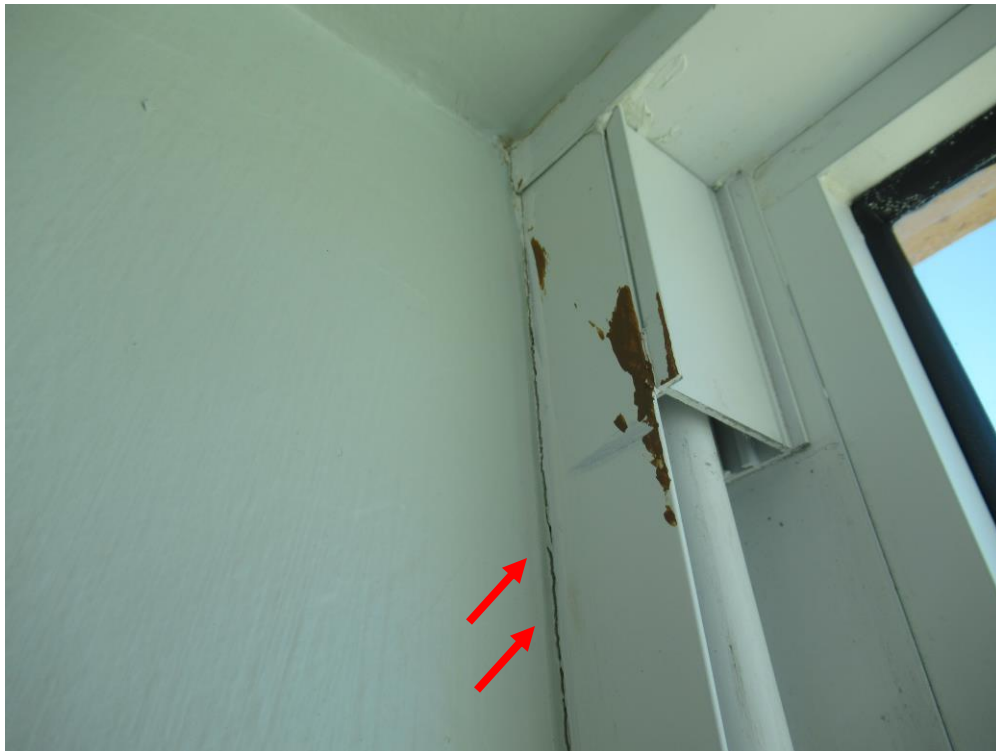
Gapping at the window frame and drywall in unit 107.

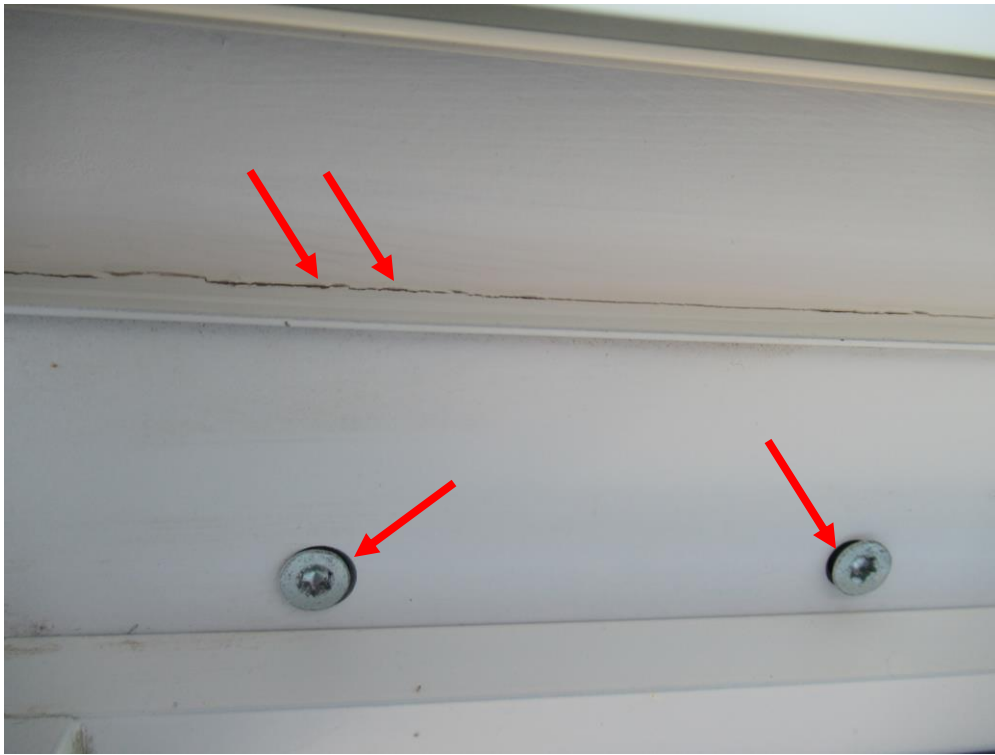
Movement of screws and gapping at the head jamb in unit 107.

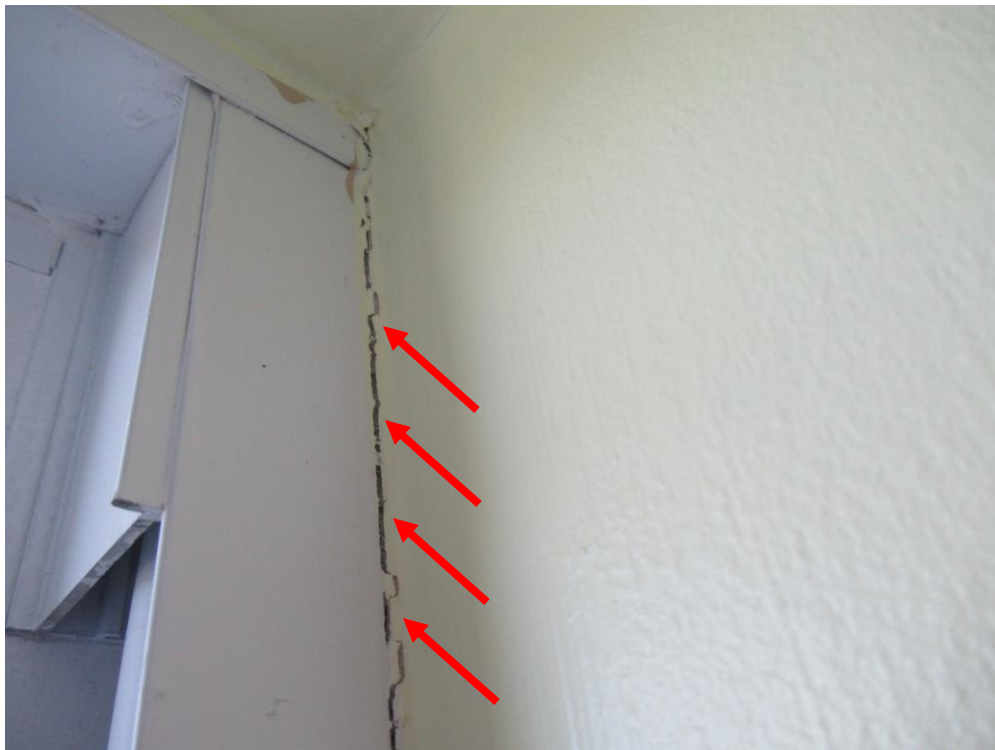
Gapping at the window frame and drywall in unit 107.

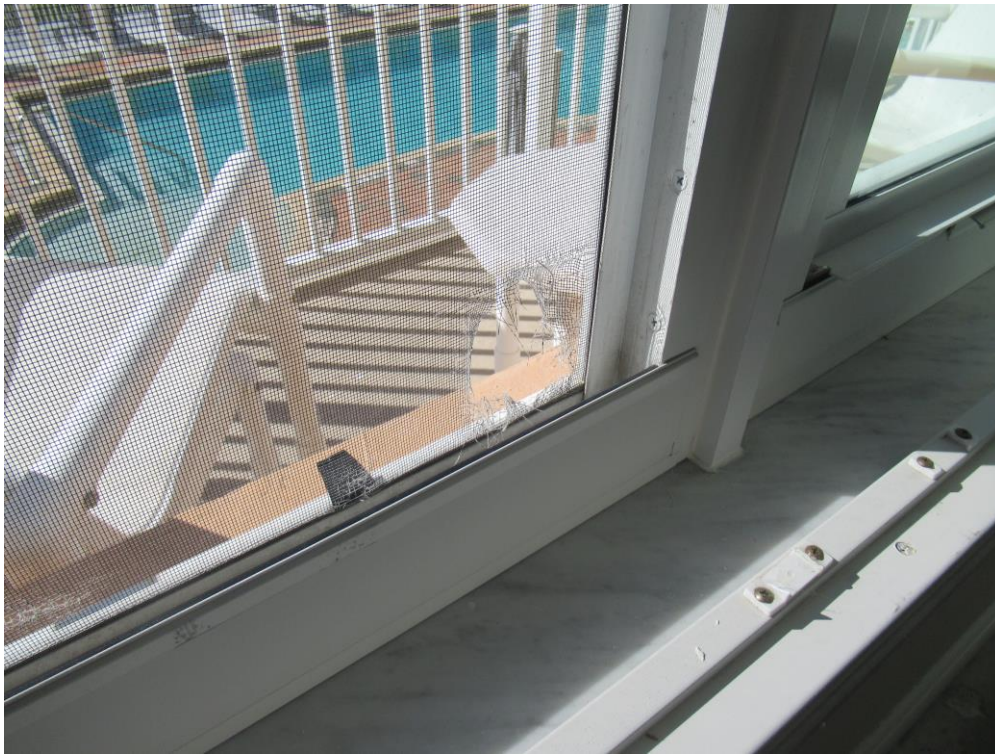
Ripped screen in unit 103.

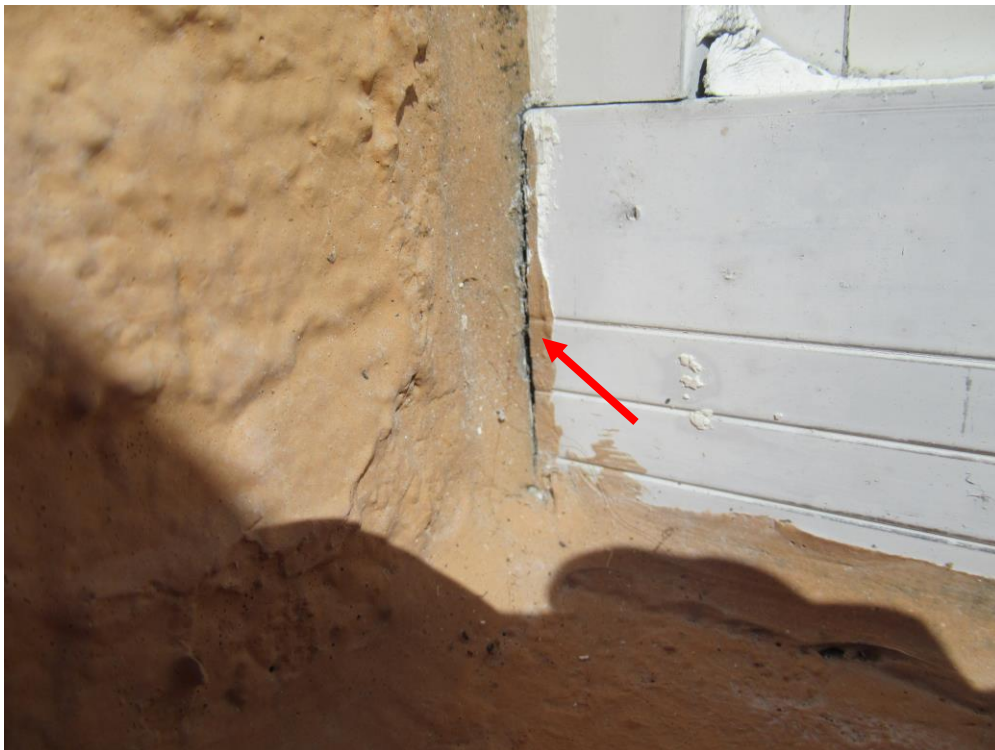
Failing window sealant, unit 102.

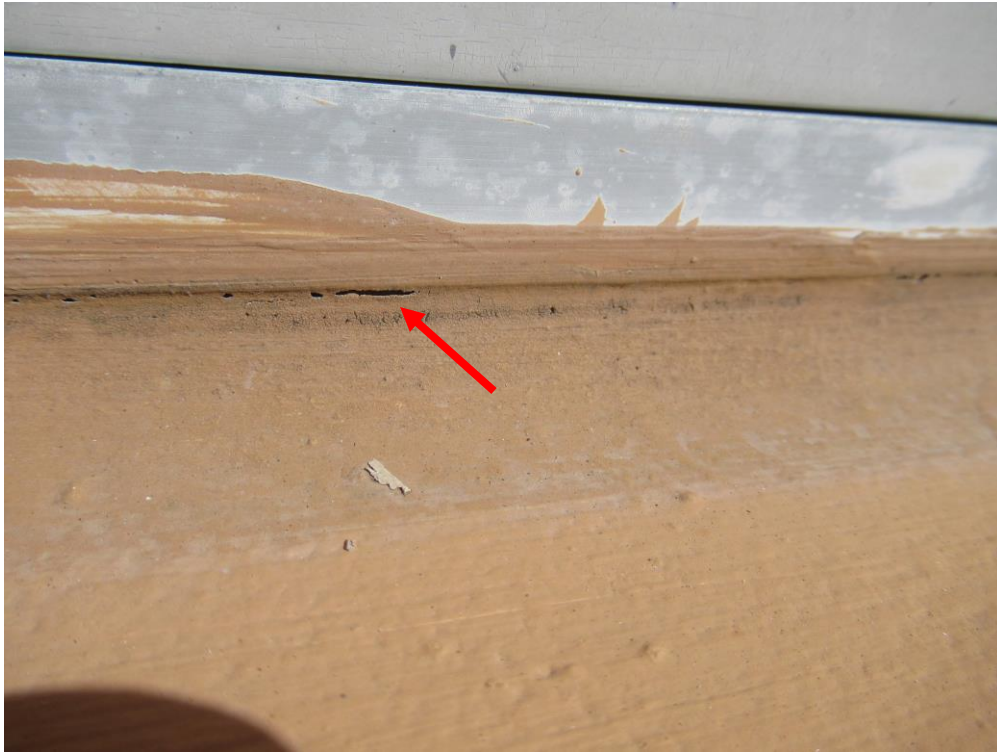
Failing window sealant, unit 101.

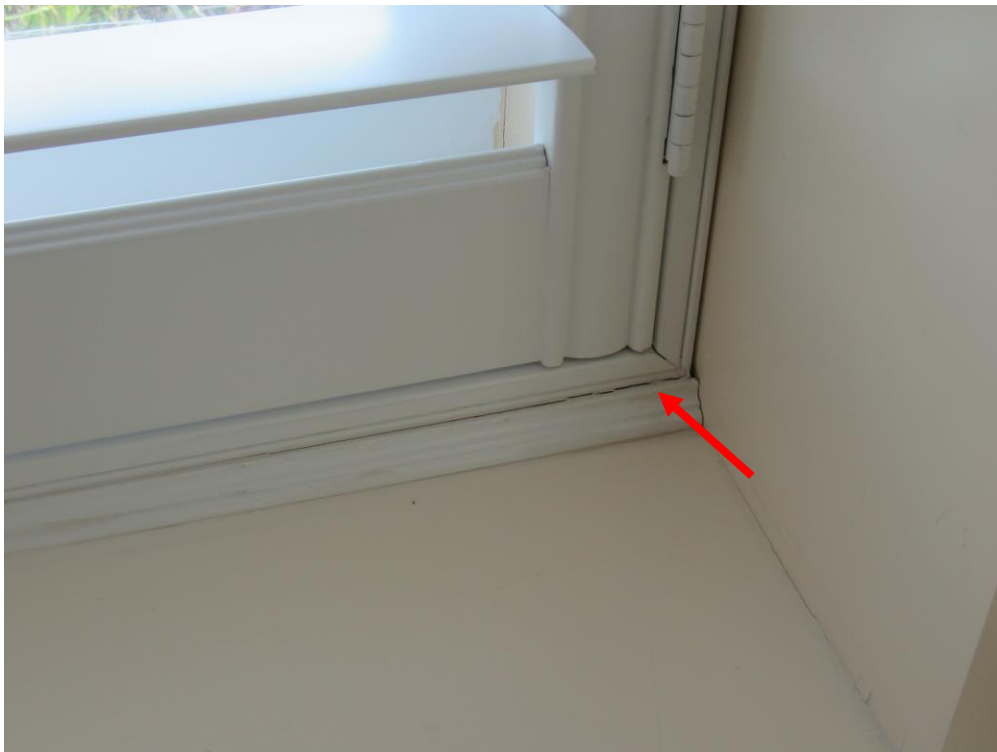
Water damage at plantation shutters, unit 101.

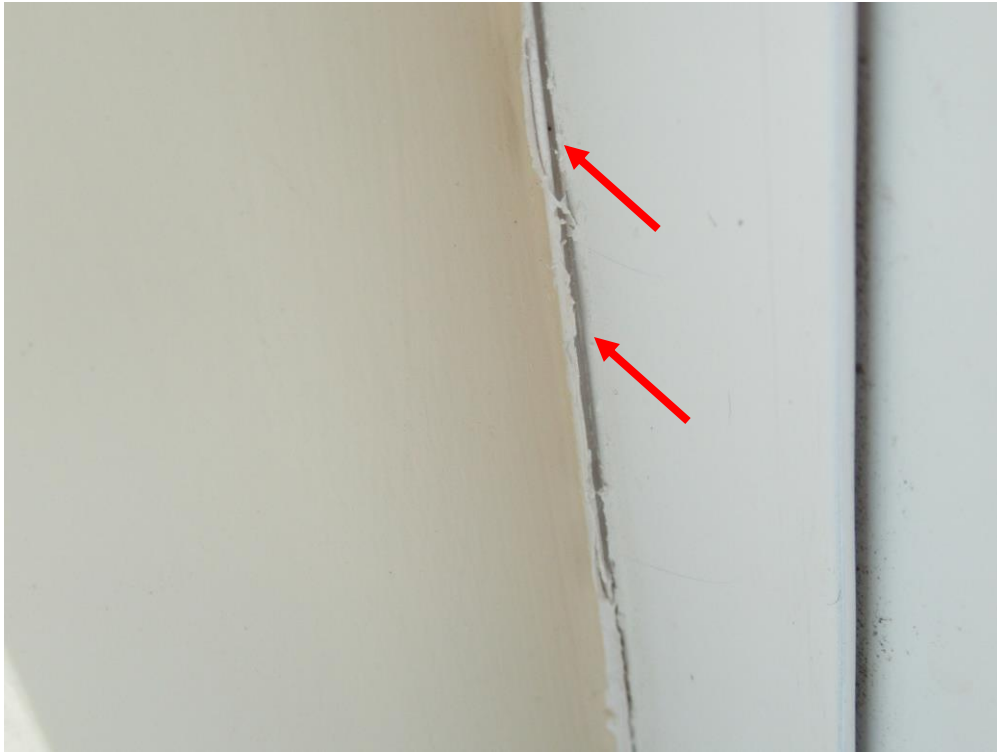
Gapping at the window frame and drywall in unit 101.

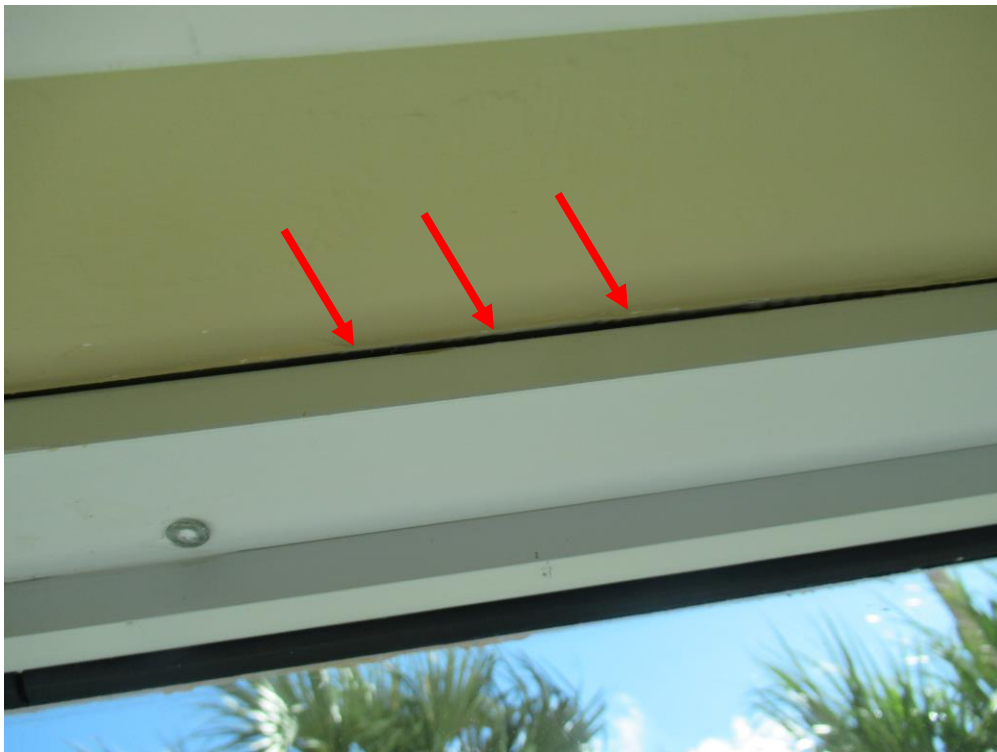
Gapping at window header, unit 101.

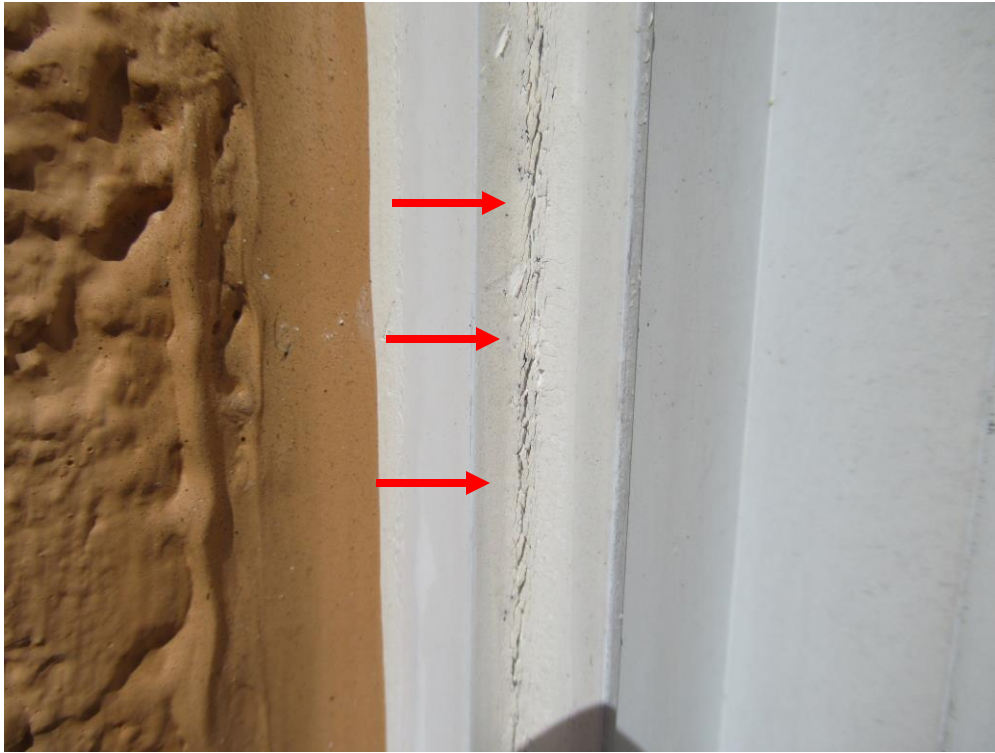
Failing window sealant, unit 106.

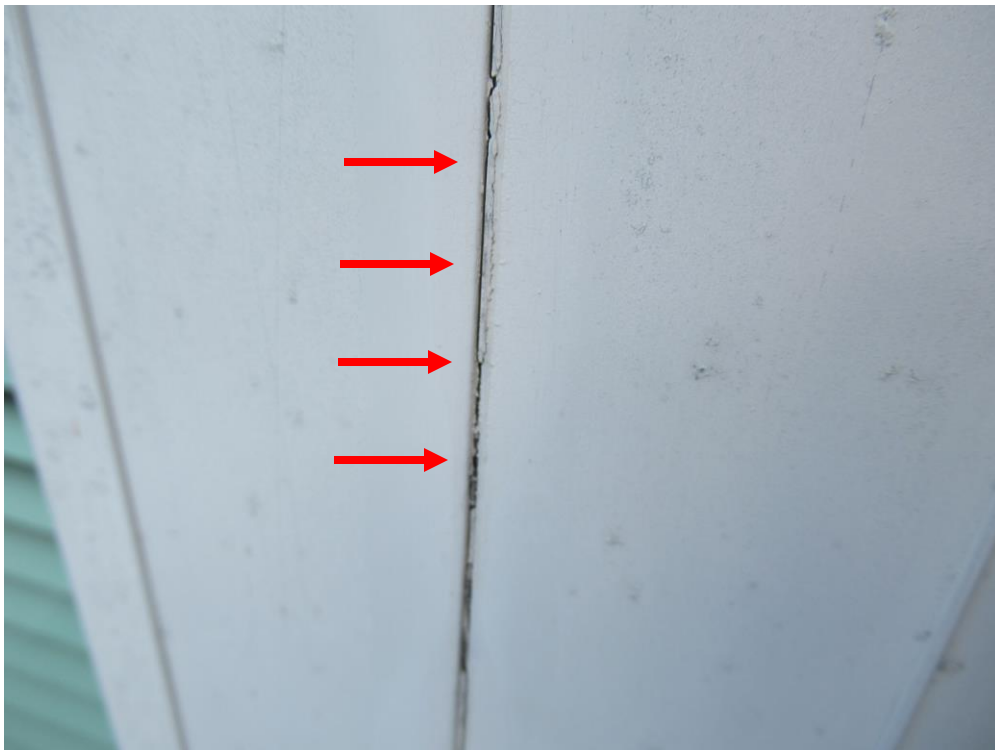
Failing window sealant at mullion at unit 105.

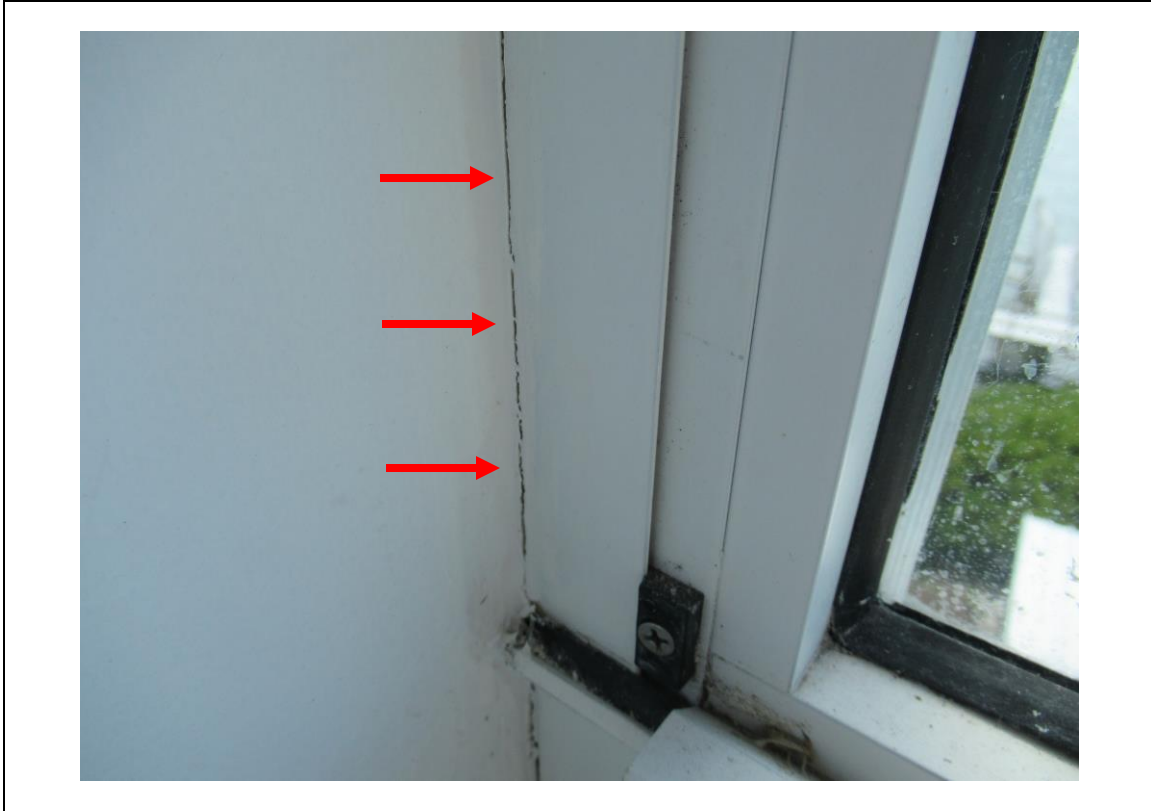
Gapping at the window frame and drywall in unit 301.

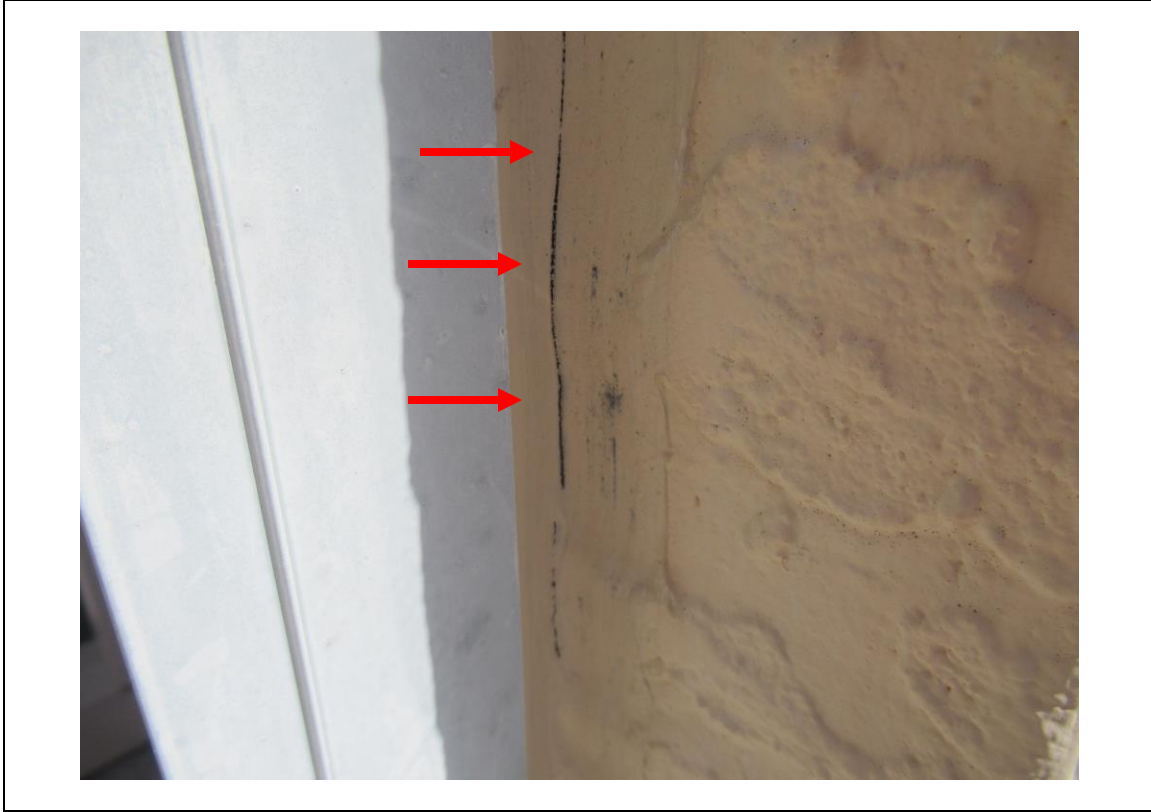
Failing window sealant, unit 301.

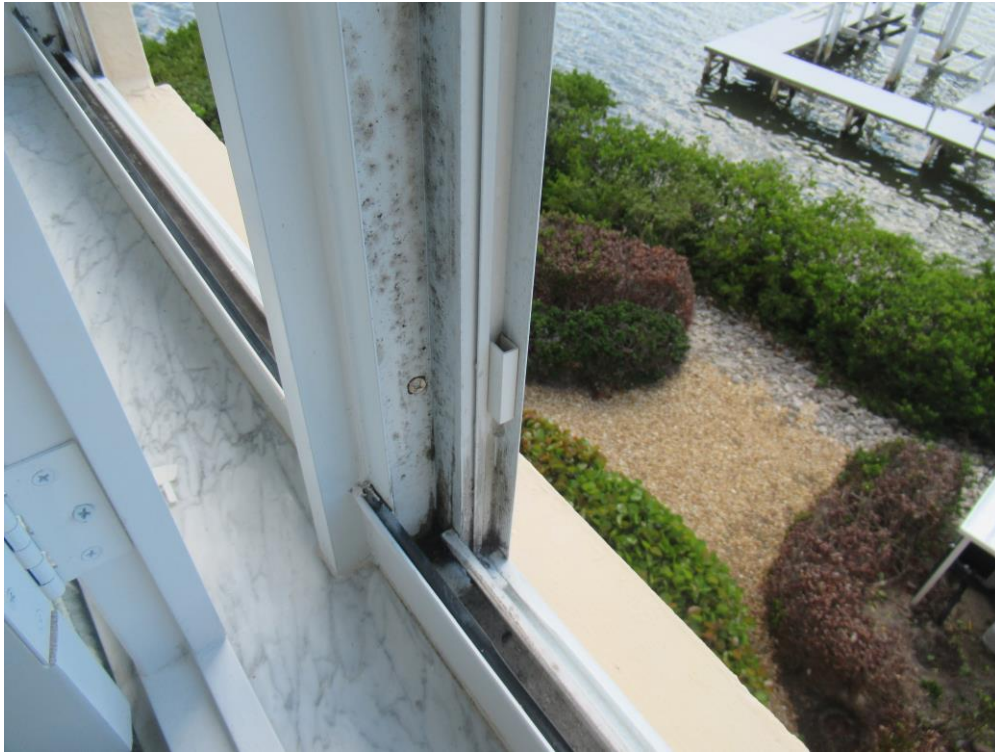
Mold spores in a window track, unit 301.

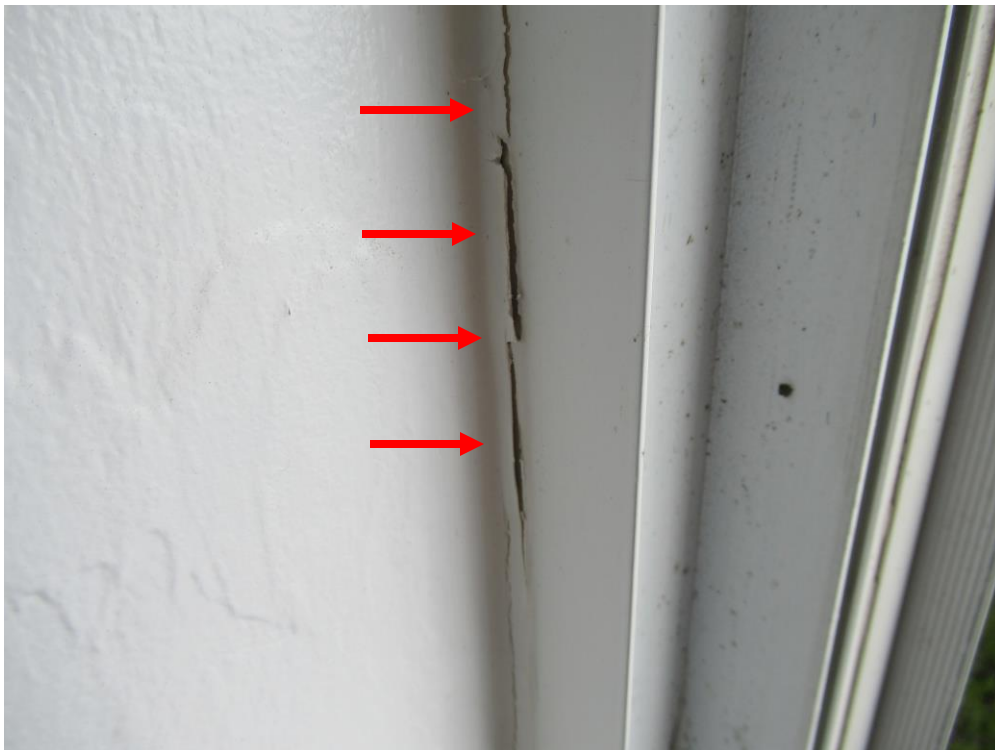
Gapping at the window frame and drywall in unit 301.

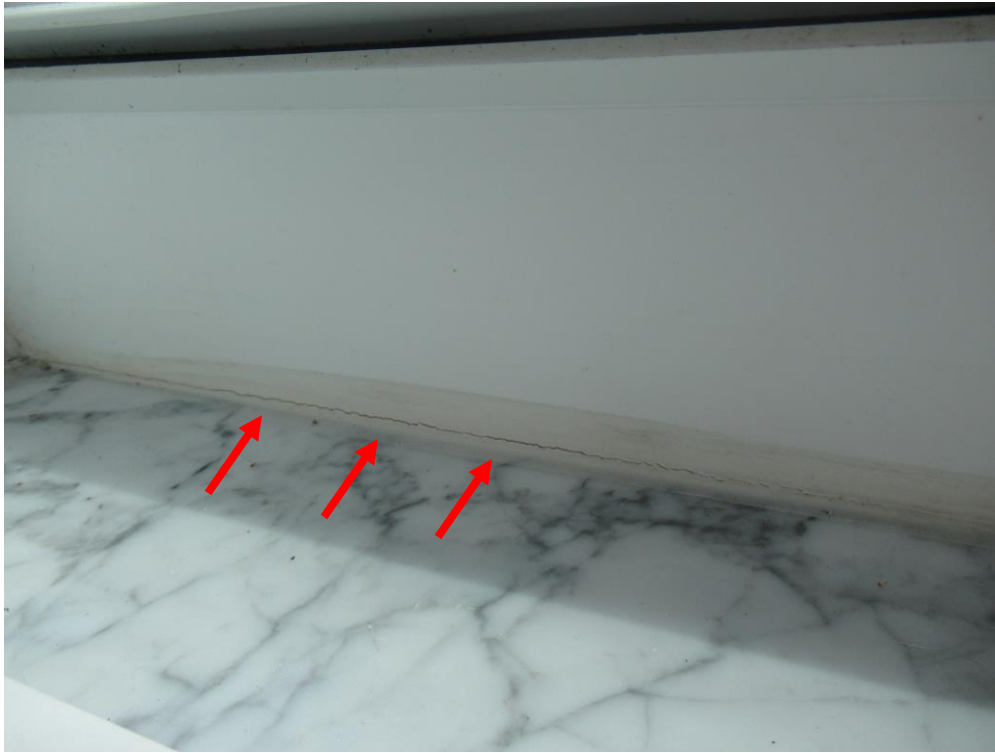
Failing window sealant, unit 301.

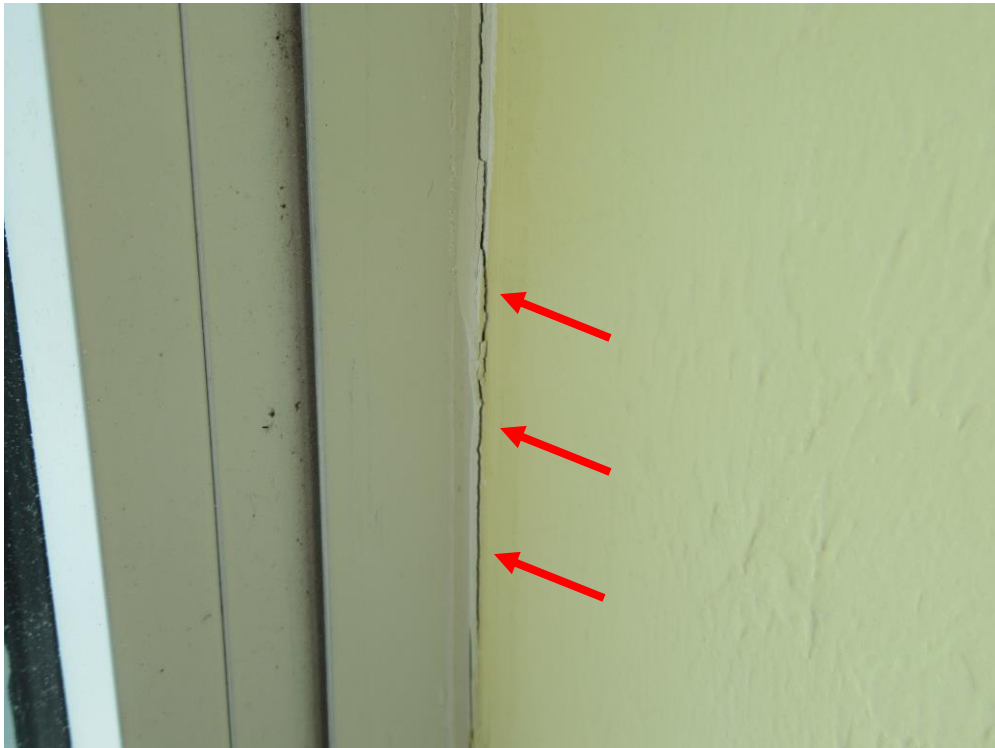
Gapping at the window frame and drywall in unit 303.

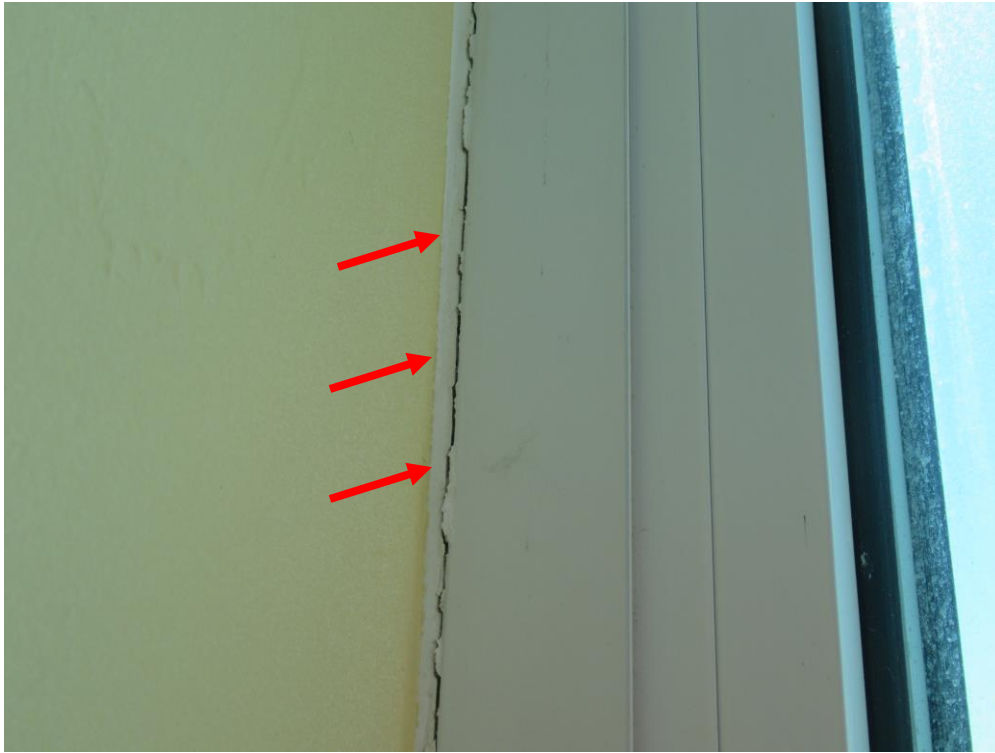
Gapping at the window frame and drywall in unit 303.

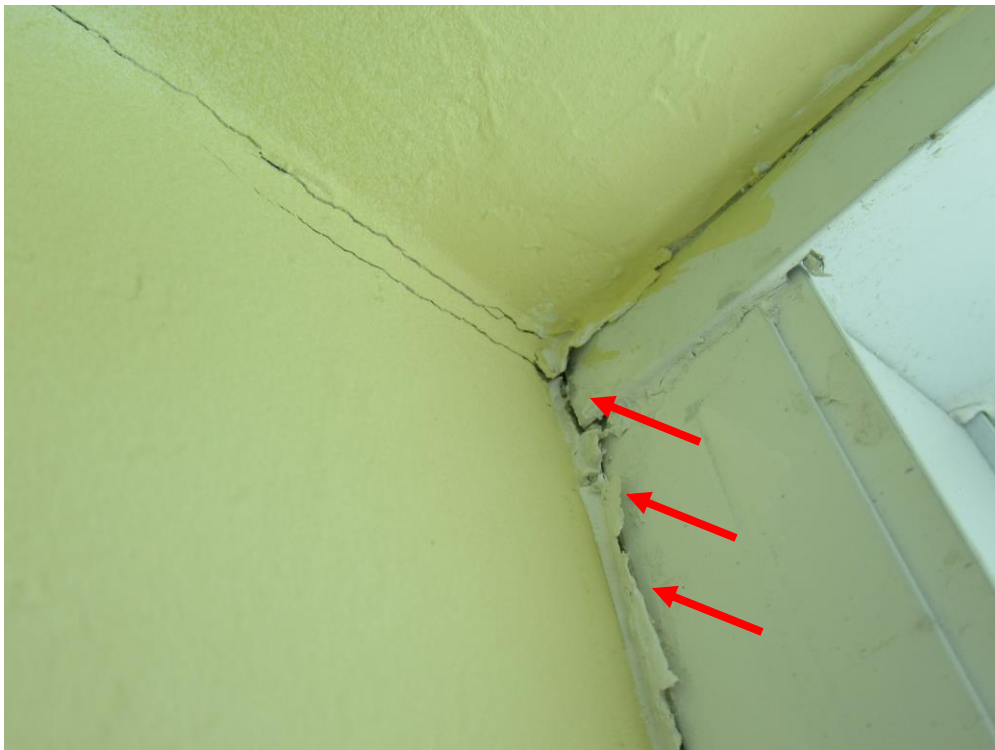
Gapping at the window frame and drywall in unit 303.

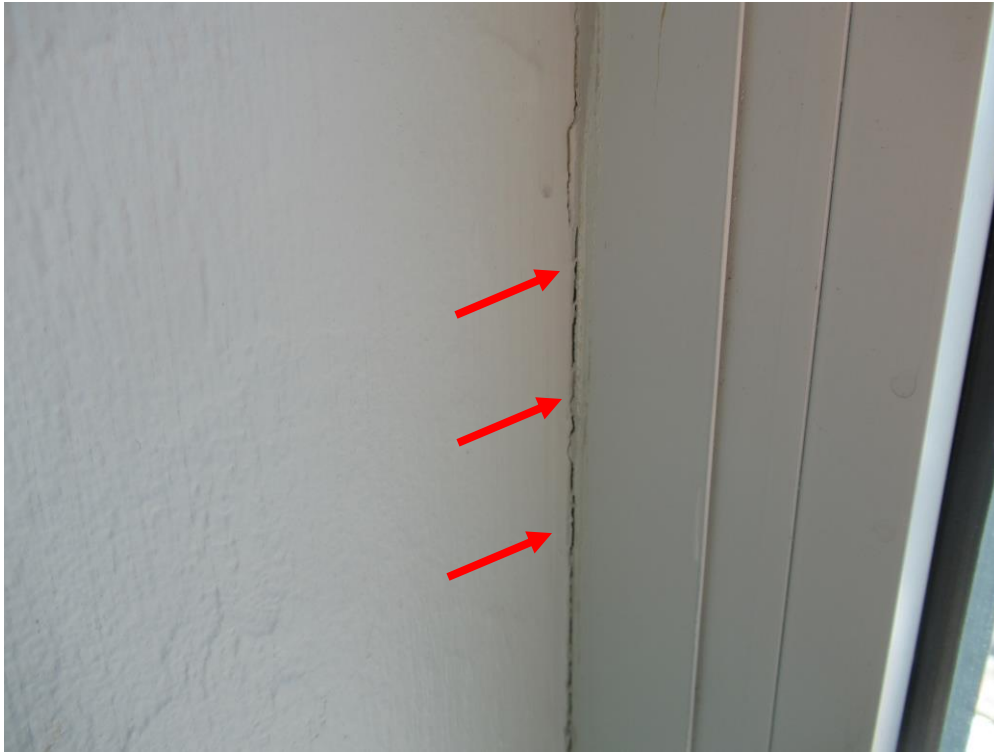
Gapping at the window frame and drywall in unit 304.

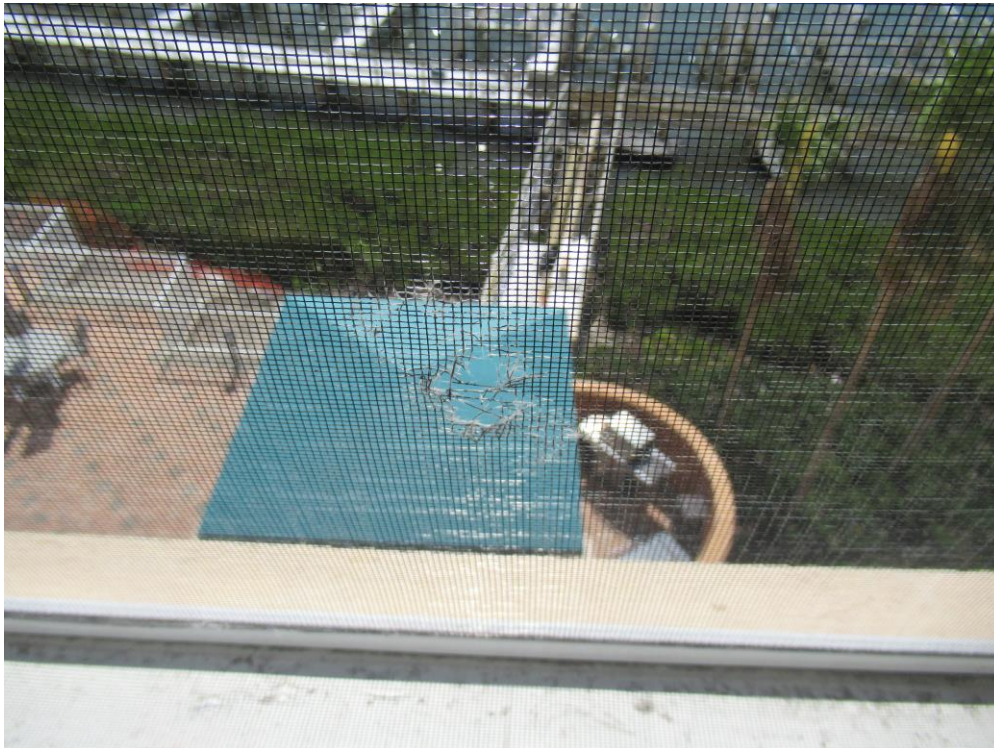
Ripped screen in unit 306.

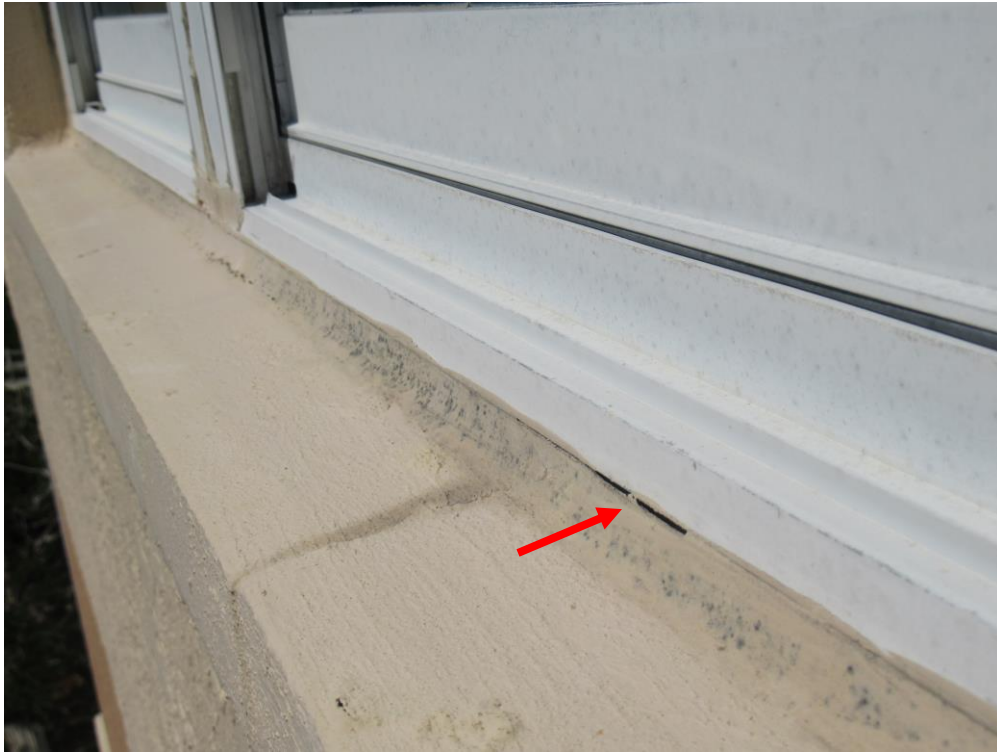
Failing window sealant, unit 307.

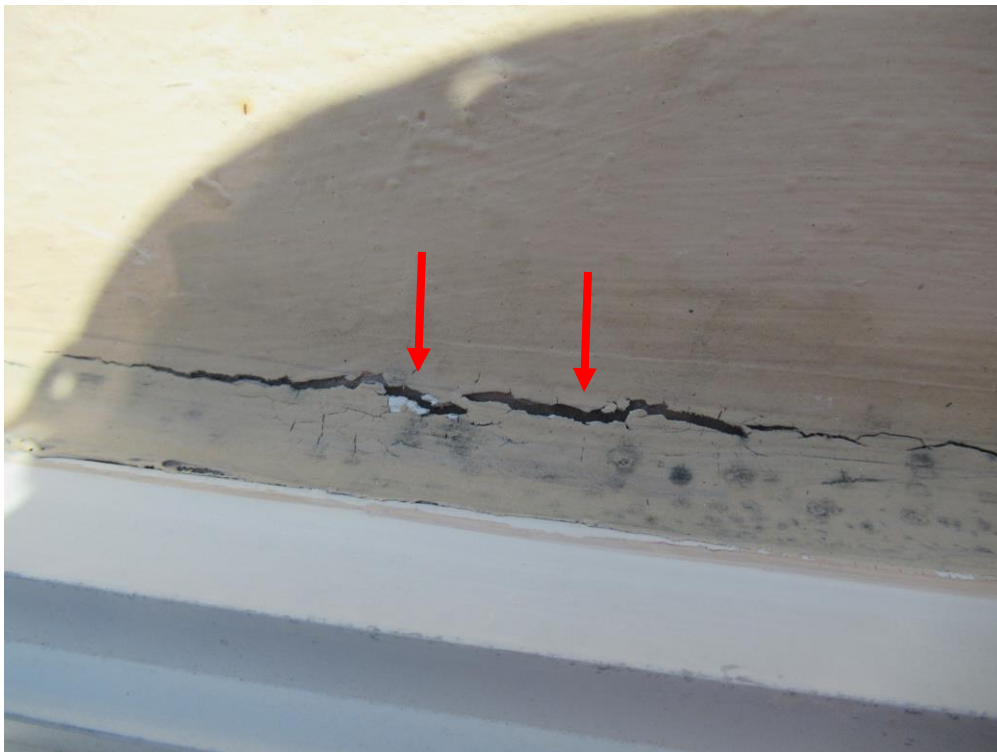
Failing window sealant, unit 506.
