**MILESTONE INSPECTION –
PHASE I REPORT**

Bridgewater at Bonita Beach Condominium
Association, Inc.
4975 Bonita Beach Road South
Bonita Springs, FL 34134

SOCOTEC Project Number 6008-003.01

March 6, 2023

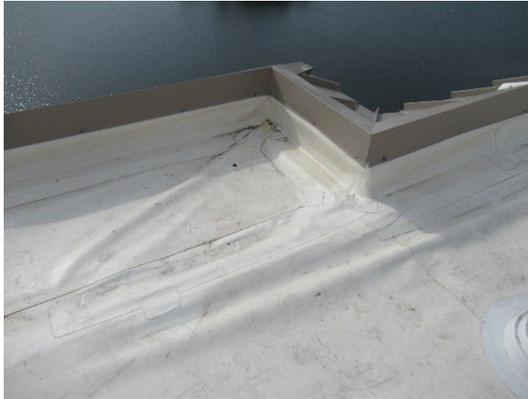
- Delaminated and cracked concrete as noted in Appendix A.
- Concrete column damage from cars in the parking garage as noted on Appendix A.
- Delaminated and blistered paint.
- Sections of the roof membrane appeared unadhered to the roof deck.
- Raised L flashing between the roof and wall.
- Sections of the roof missing at the low parapet cap.

<p>View of unadhered roof membrane and bent flashing.</p>	<p>View of mansard roof attic space.</p>

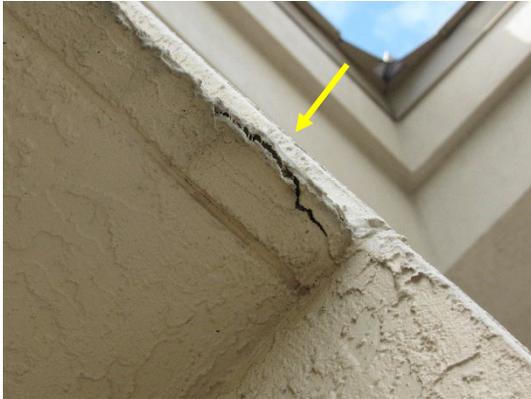
<p>View of typical skylight.</p>	<p>View of delaminated stucco on the 6th floor breezeway.</p>

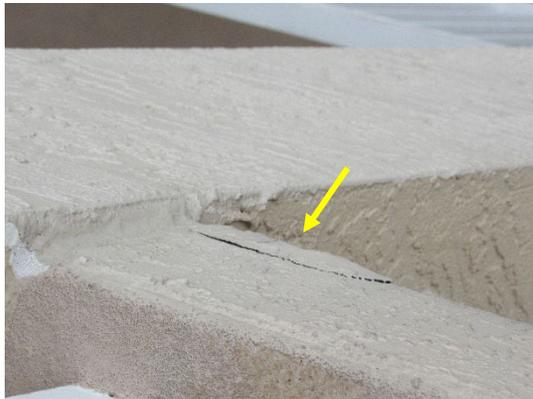
<p>View of delaminated stucco on the PH floor breezeway.</p>	<p>View of hole in the stucco and delaminated concrete on the 4th floor breezeway.</p>

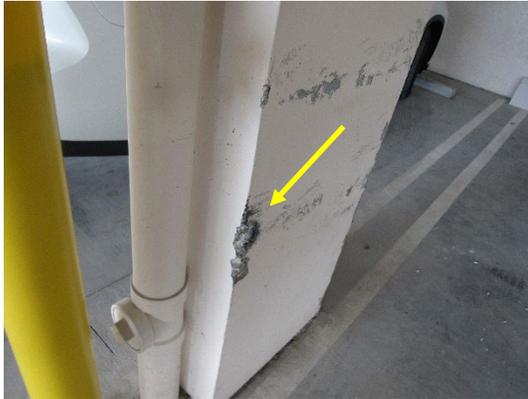
A photograph showing a brick pillar in a garage. A large, jagged hole has been made in the brick and stucco, with a car's bumper visible at the top of the opening.
<p>View of damaged column in garage from car impact.</p>	<p>View of damaged stucco in garage from car impact.</p>

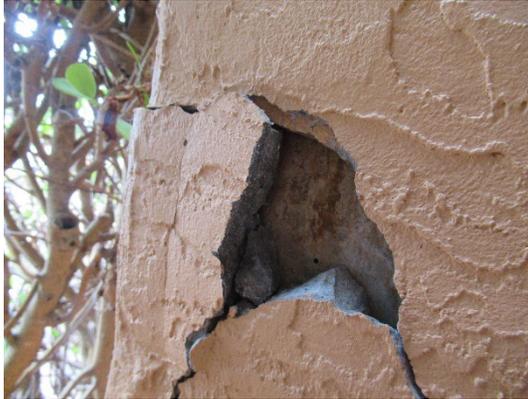
A close-up photograph of a textured, light-colored stucco wall. A yellow arrow points to a small, raised, circular area on the surface, which is a typical paint blister.
<p>Spalling stucco on the exterior.</p>	<p>View of typical paint blister.</p>

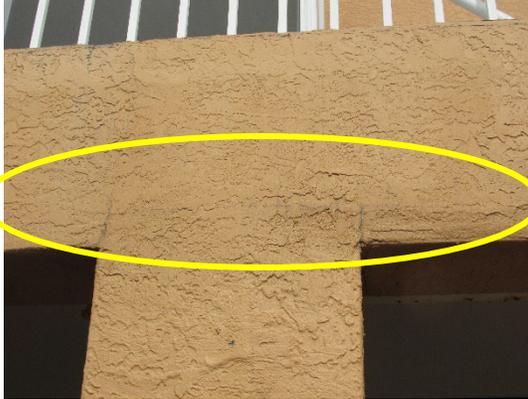
<p>View of delaminated stucco on the exterior.</p>	<p>View of stucco crack and corrosive staining.</p>

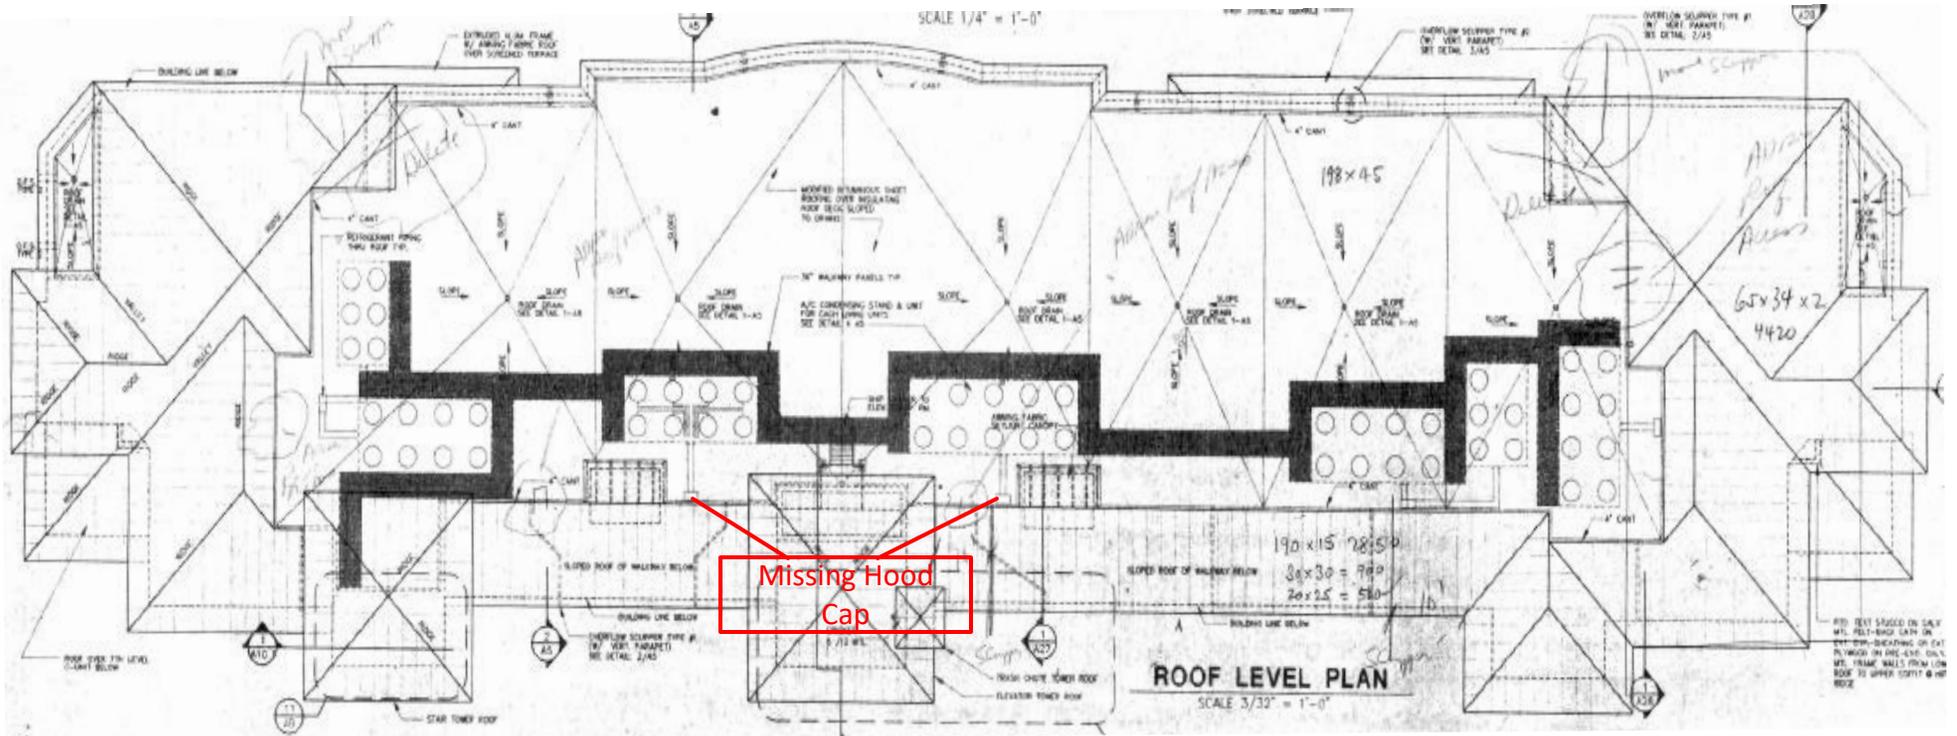
ROOF

- Sections of the roof membrane appeared unadhered to the roof deck.
- Raised L flashing between the roof and wall.
- Sections of the roof missing at the low parapet cap.

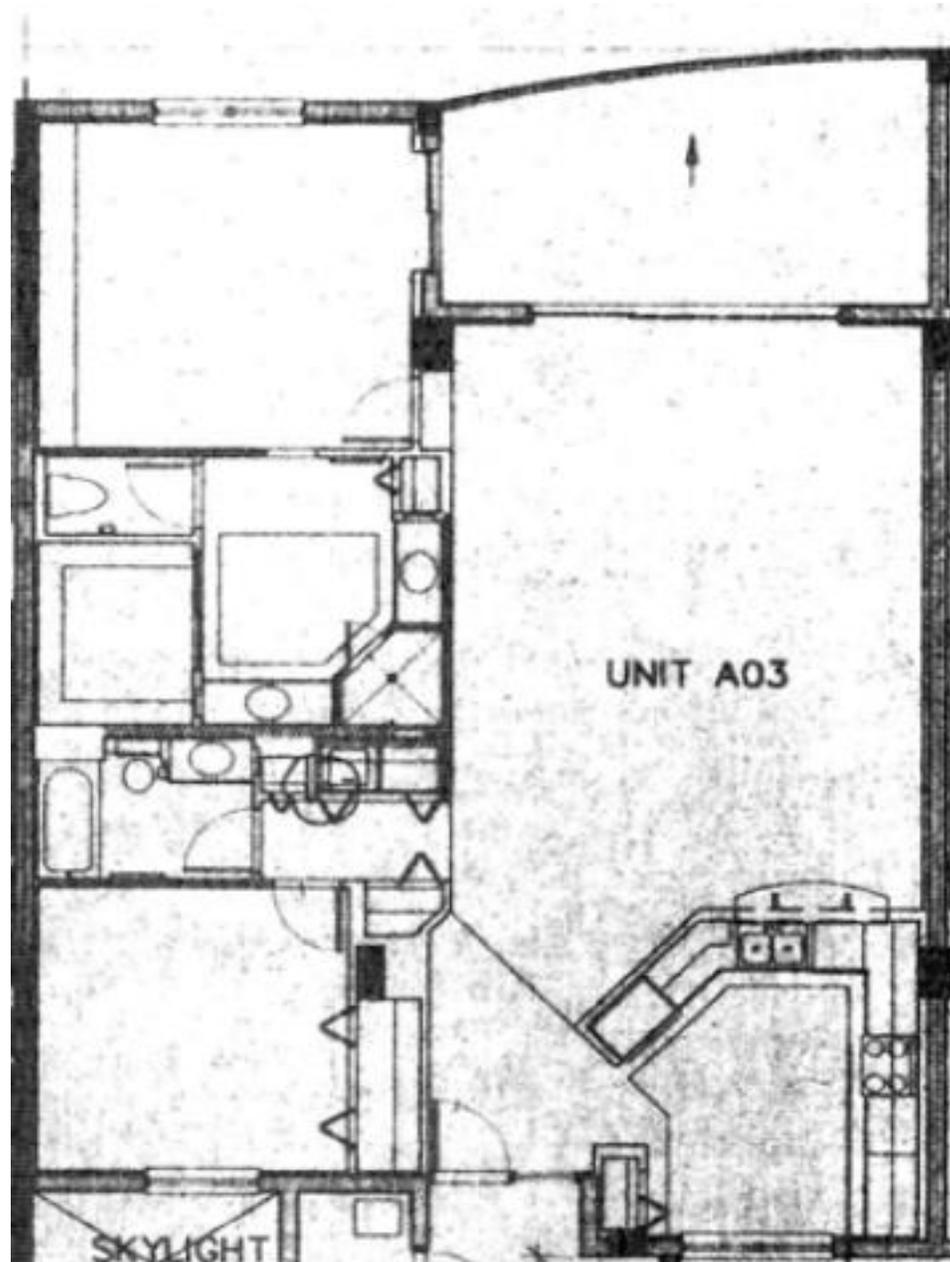
UNIT 603

Note: Unit under renovation.
Balcony tile removed, no
waterproofing membrane.
